Situation Photo Log

Thursday, November 15, 2012

Kalamazoo River / Enbridge Spill

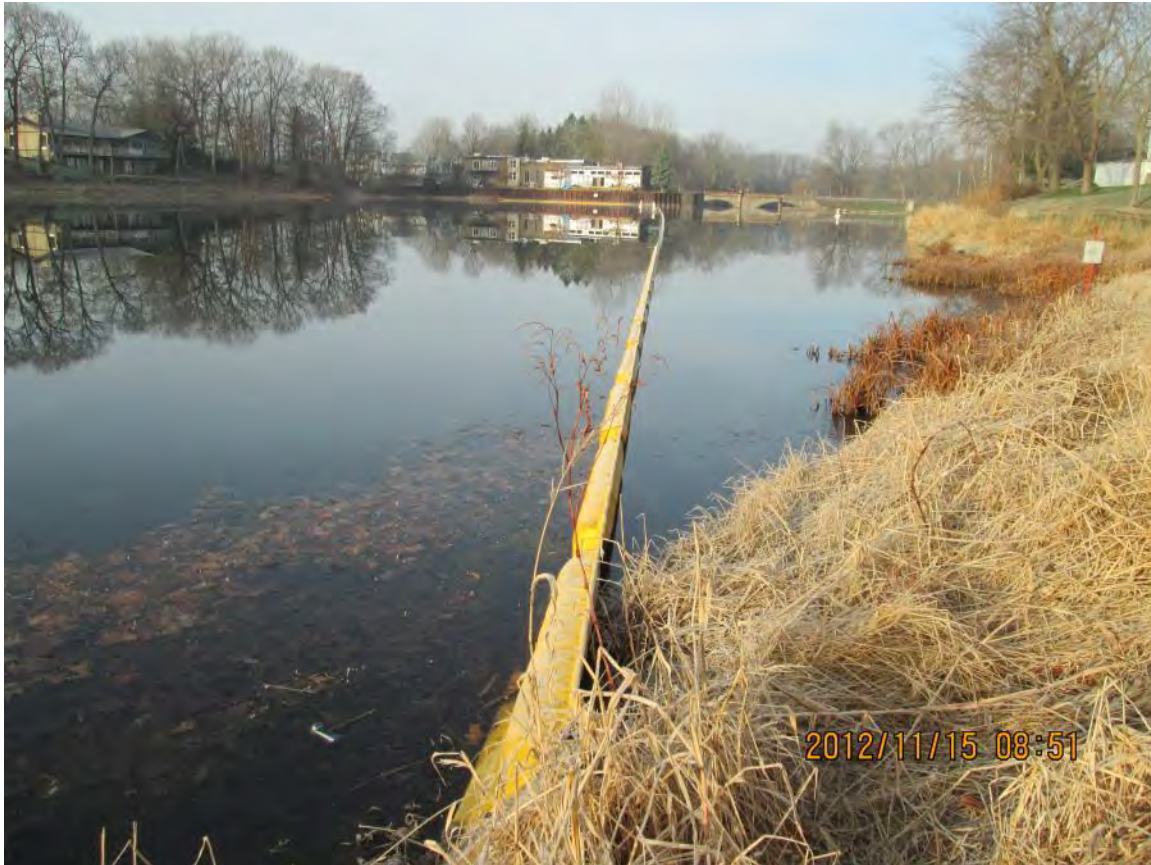
1. Ceresco Dam Control Point Boom.

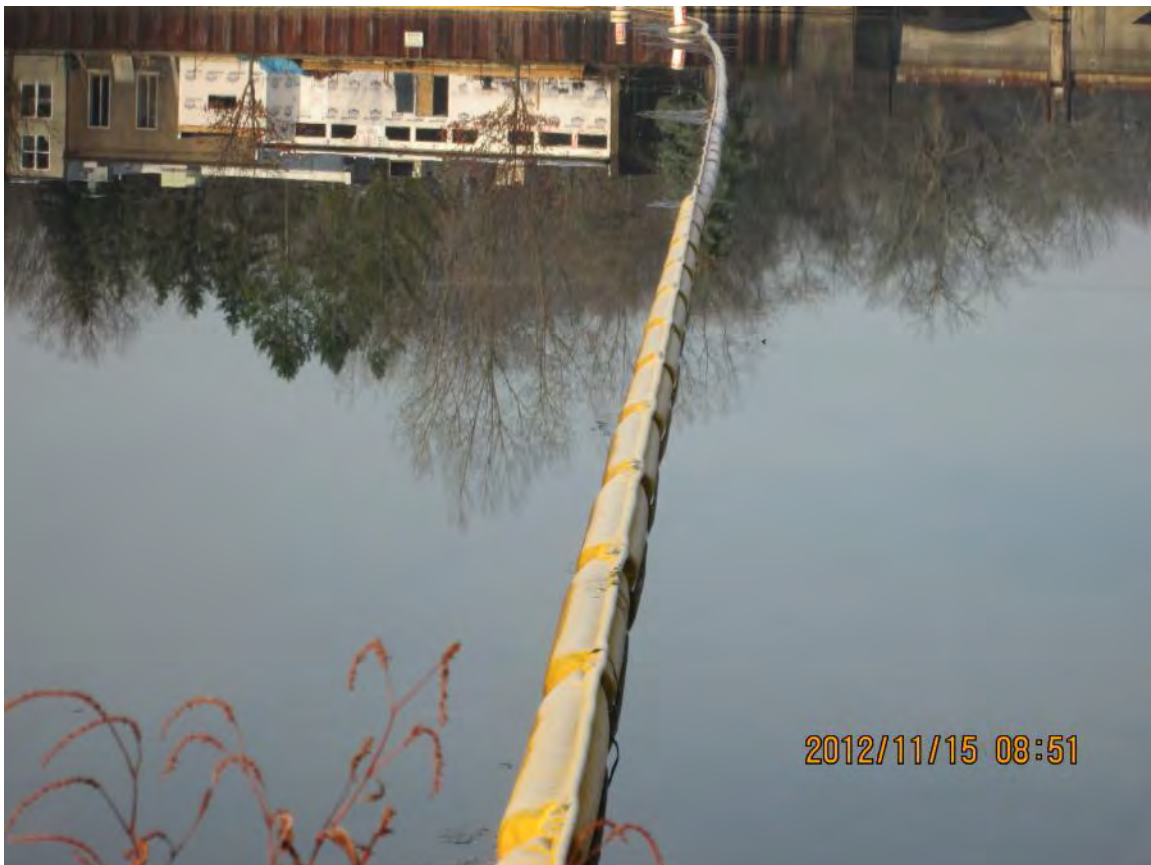
2. Ceresco Dam control point boom observed morning frost on boom.

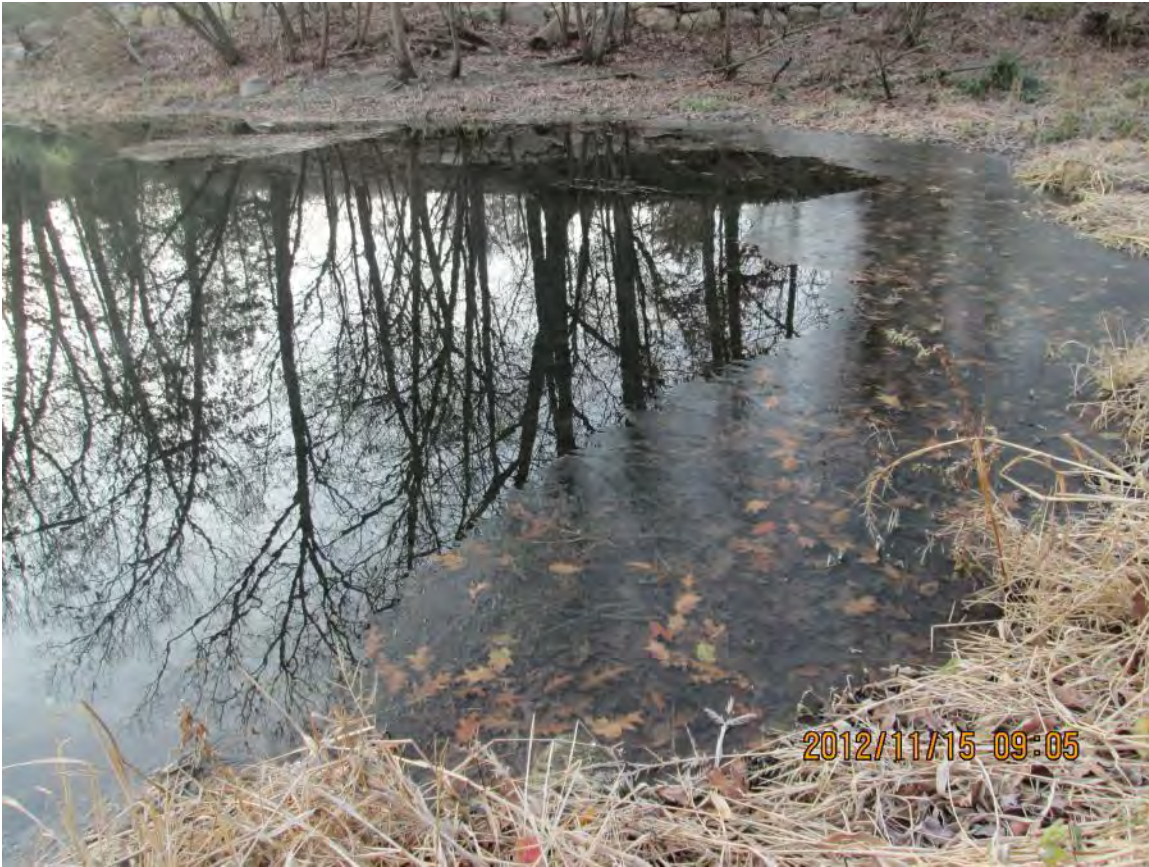
3. MP5.75 LDB observed very thin shoreline ice along southwest corner at Ceresco Dam.

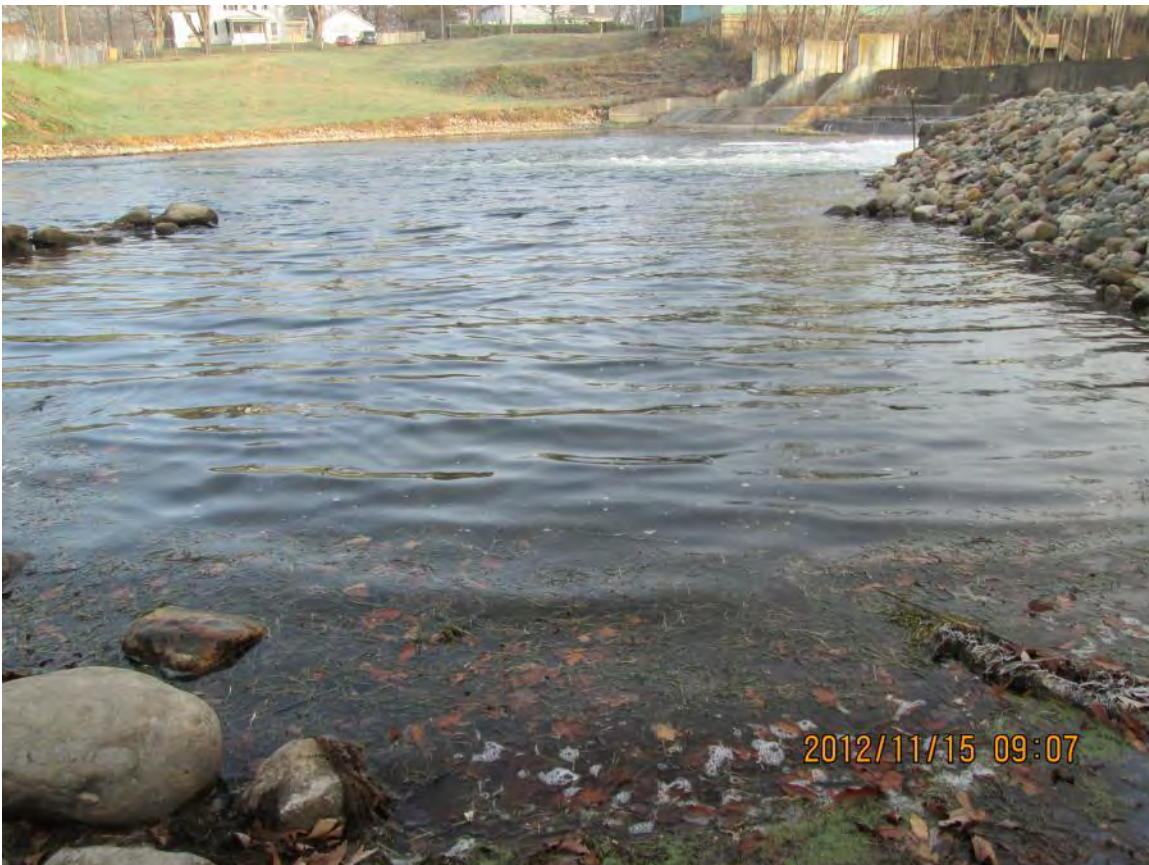
4. MP5.80 LDB area where sheen observed.

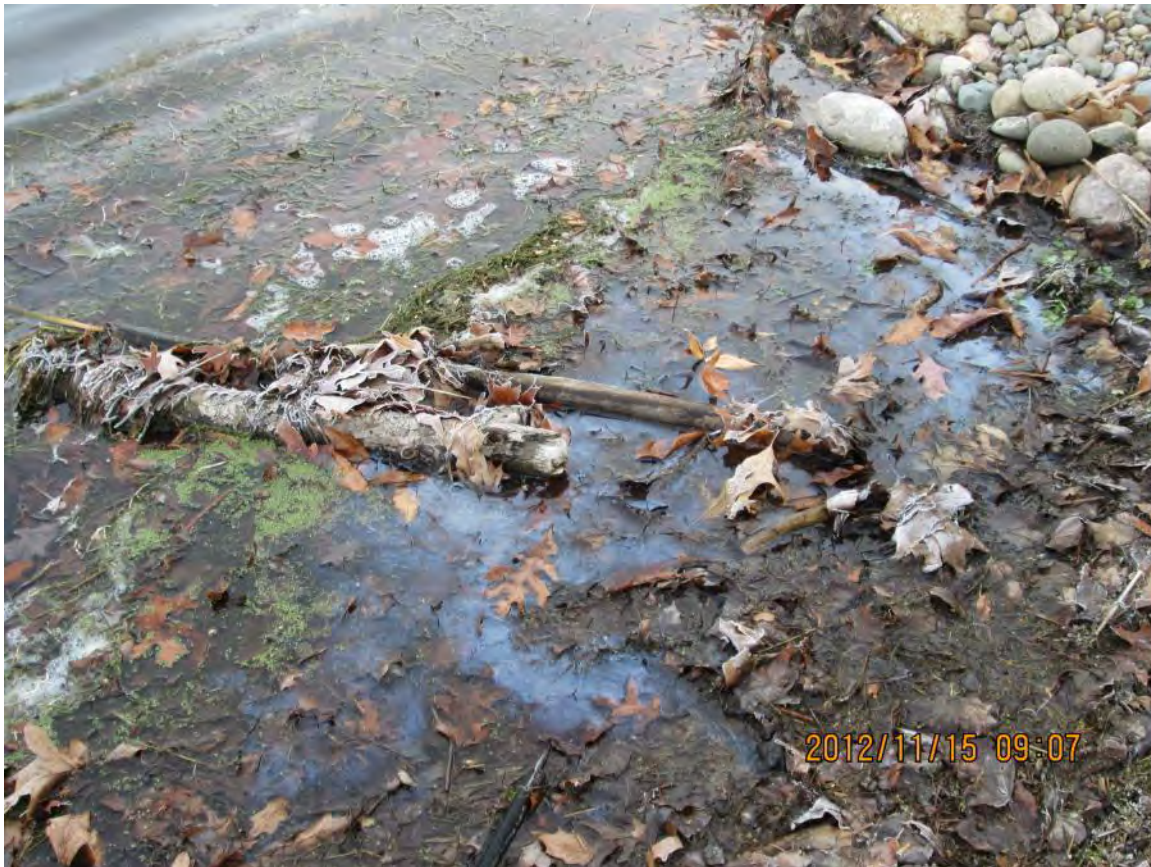
5. MP5.80 LDB sheen observed.

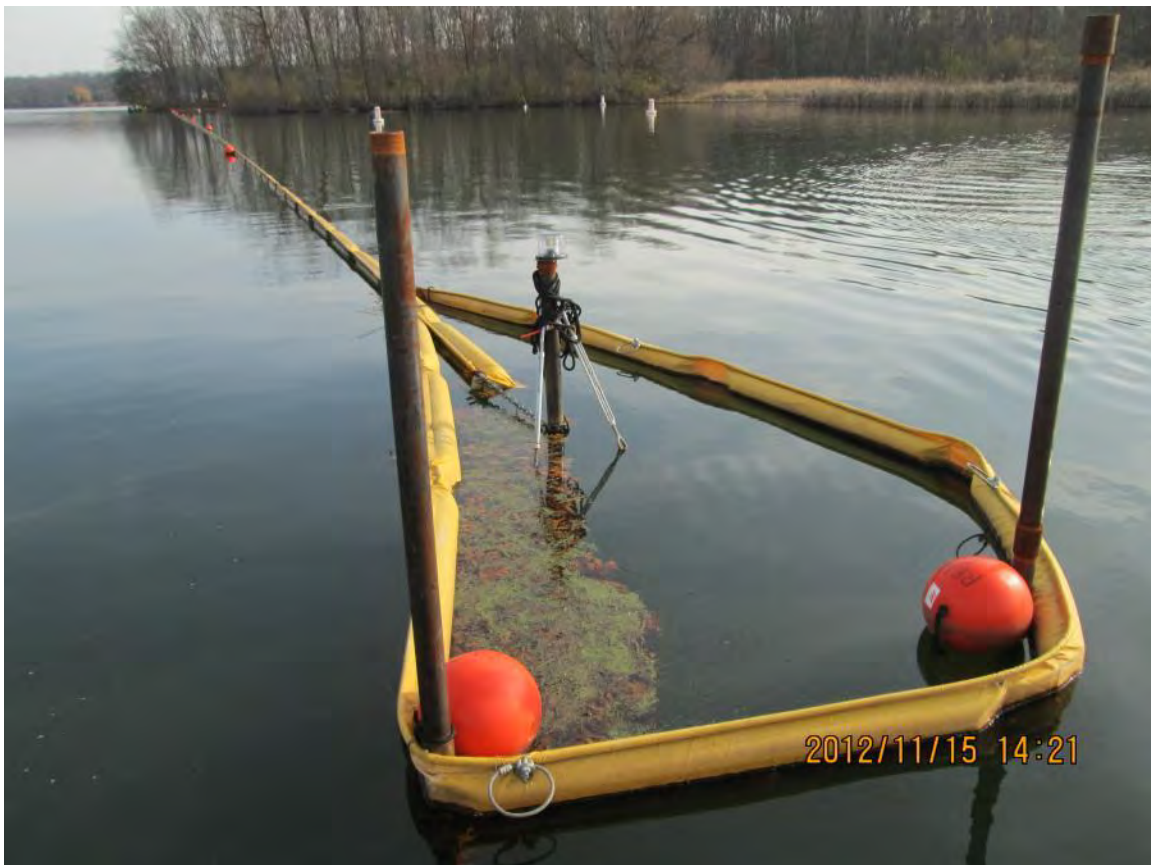
6. Morrow Lake Delta Gate E observed boat generated sheen along the boom.

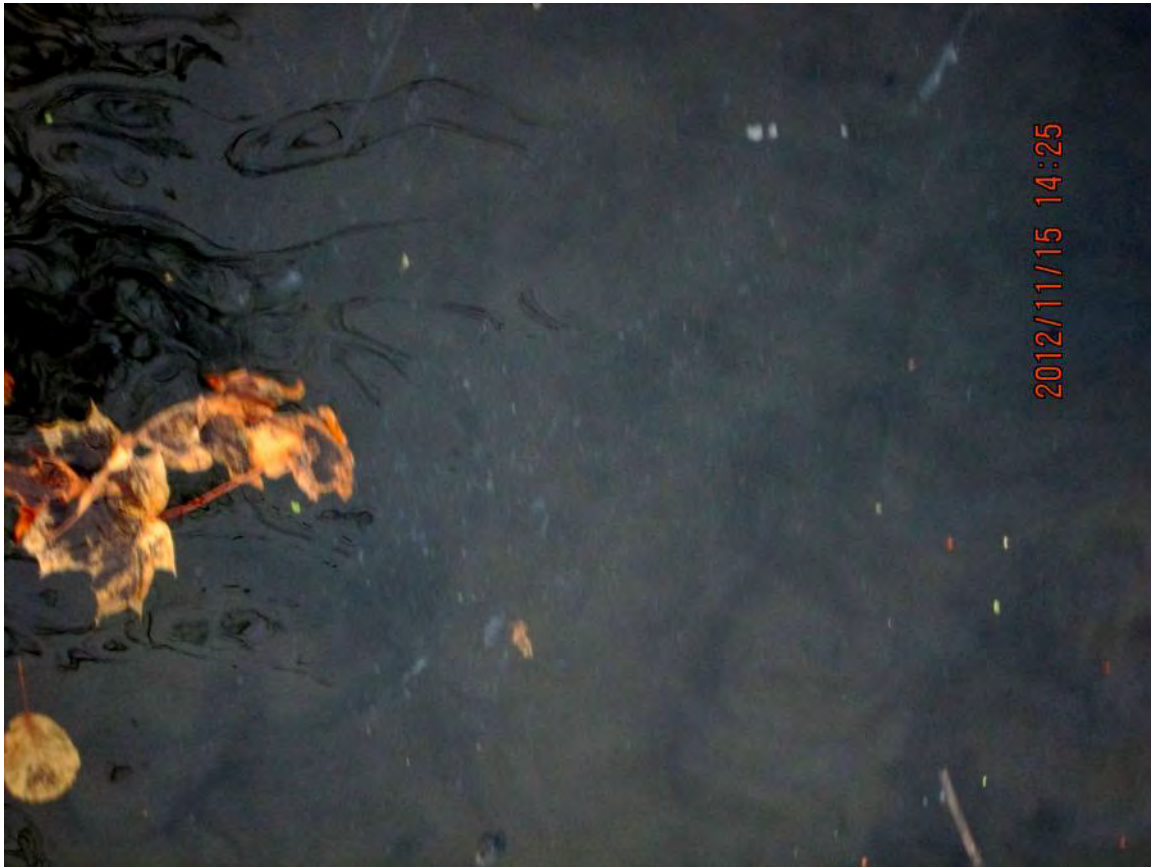
7. Morrow Lake Delta Gate E boat generated sheen observed along the boom.

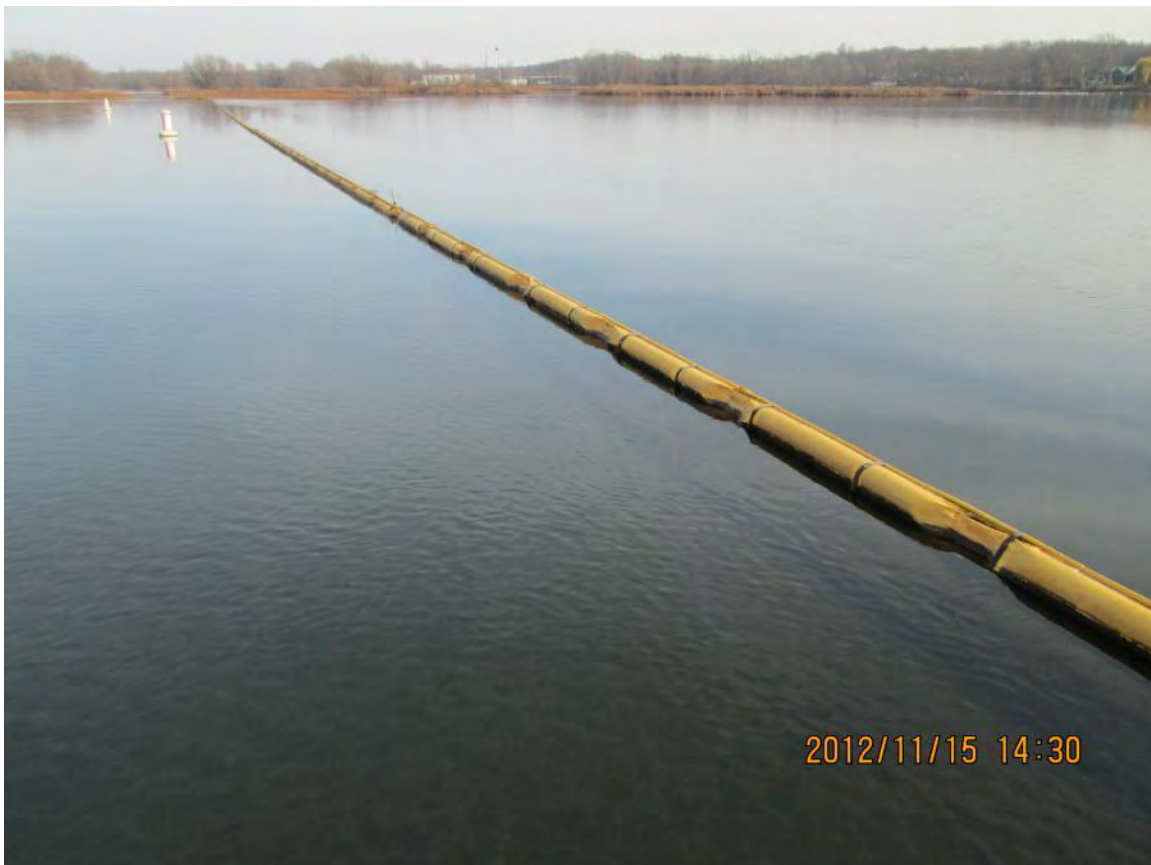
8. Morrow Lake Delta Gate C observed sheen along the boom.

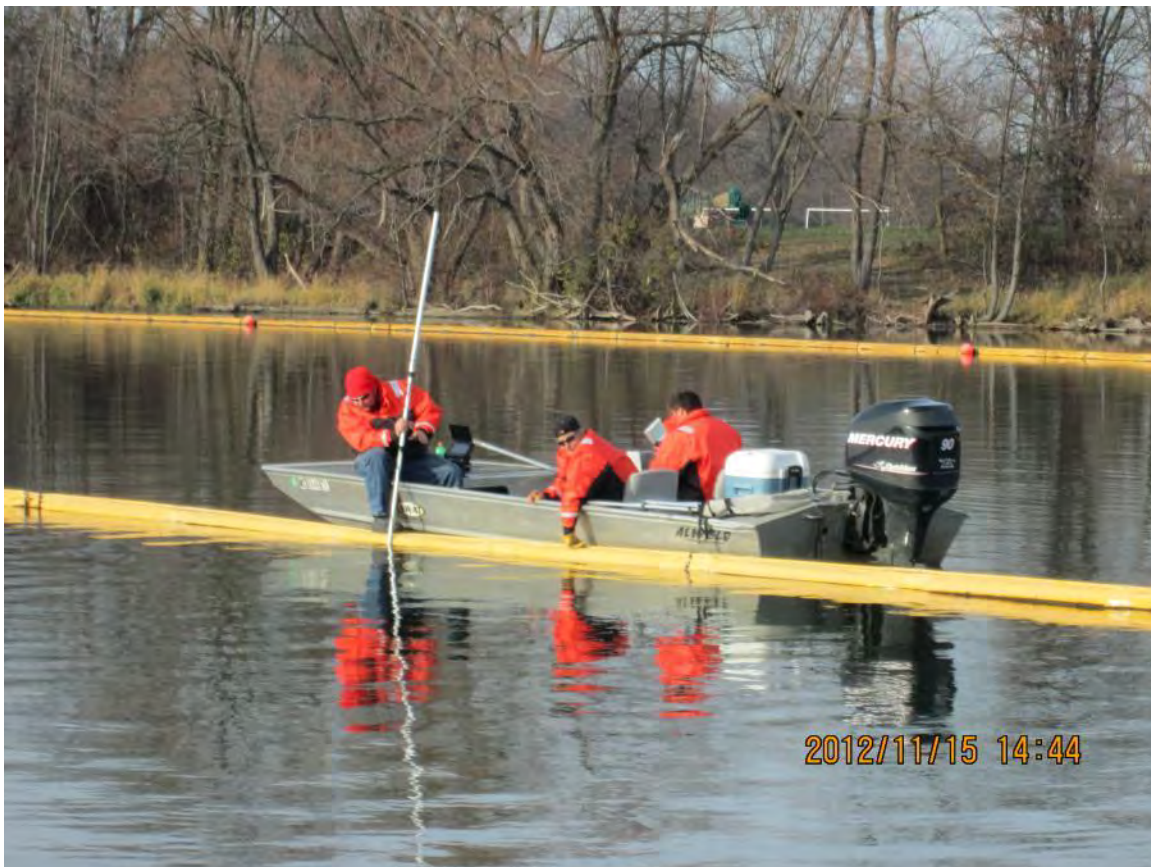
10. Morrow Lake Delta Gate F observed crew inspecting curtain.

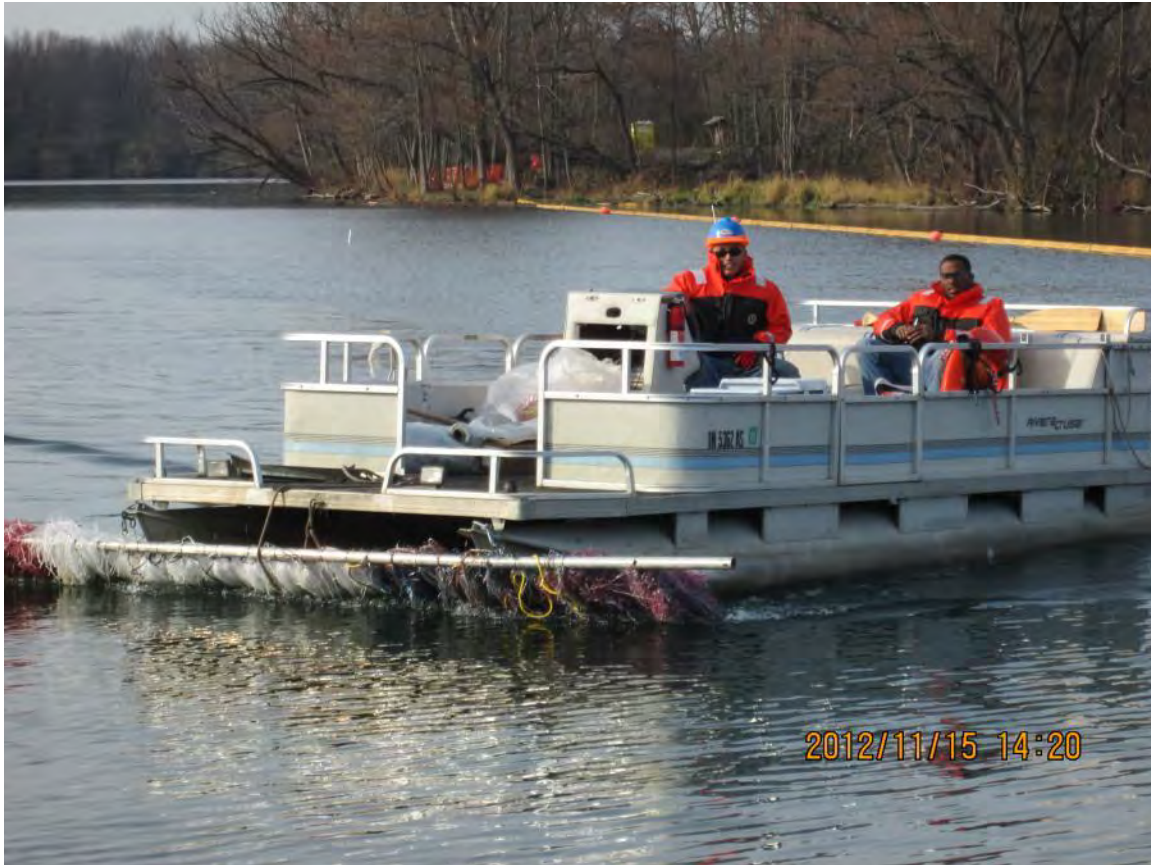
11. Morrow Lake Delta observed sweep boat crew.

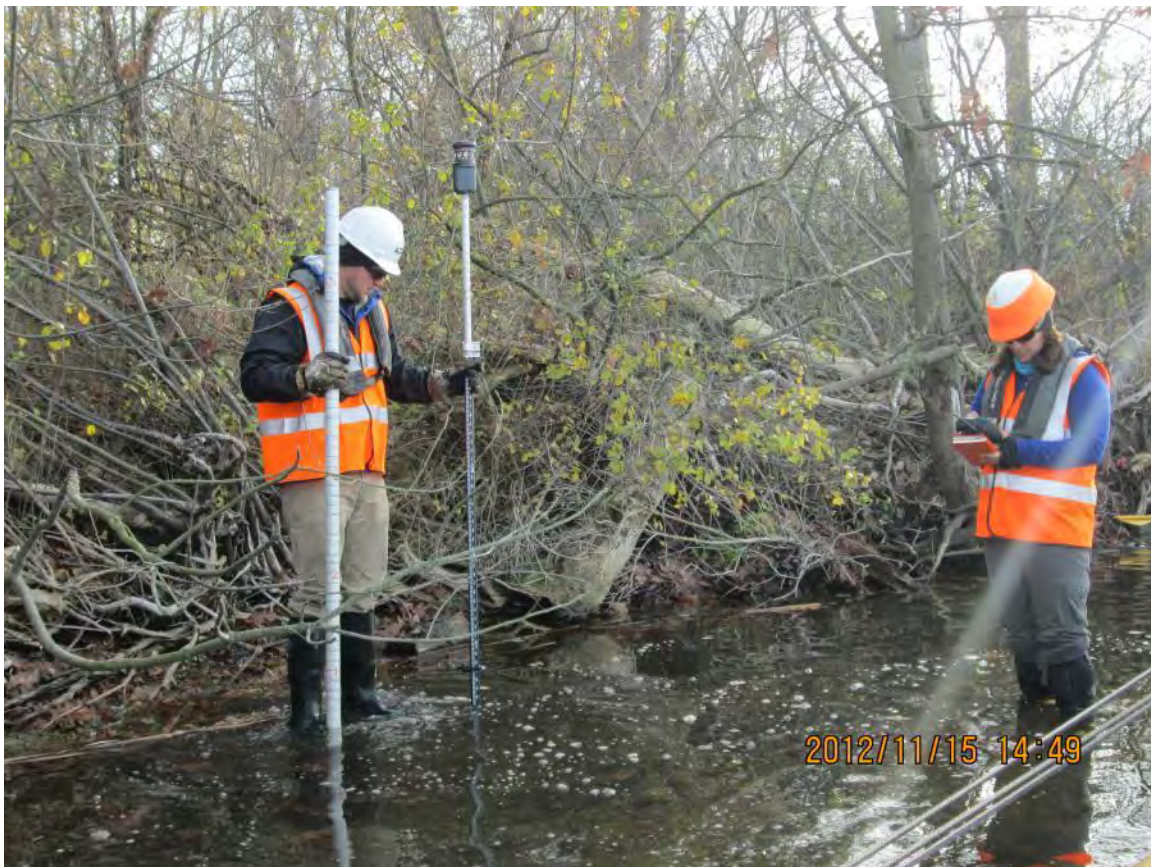
12. Morrow Lake Delta Gate E observed a Bathymetry team.

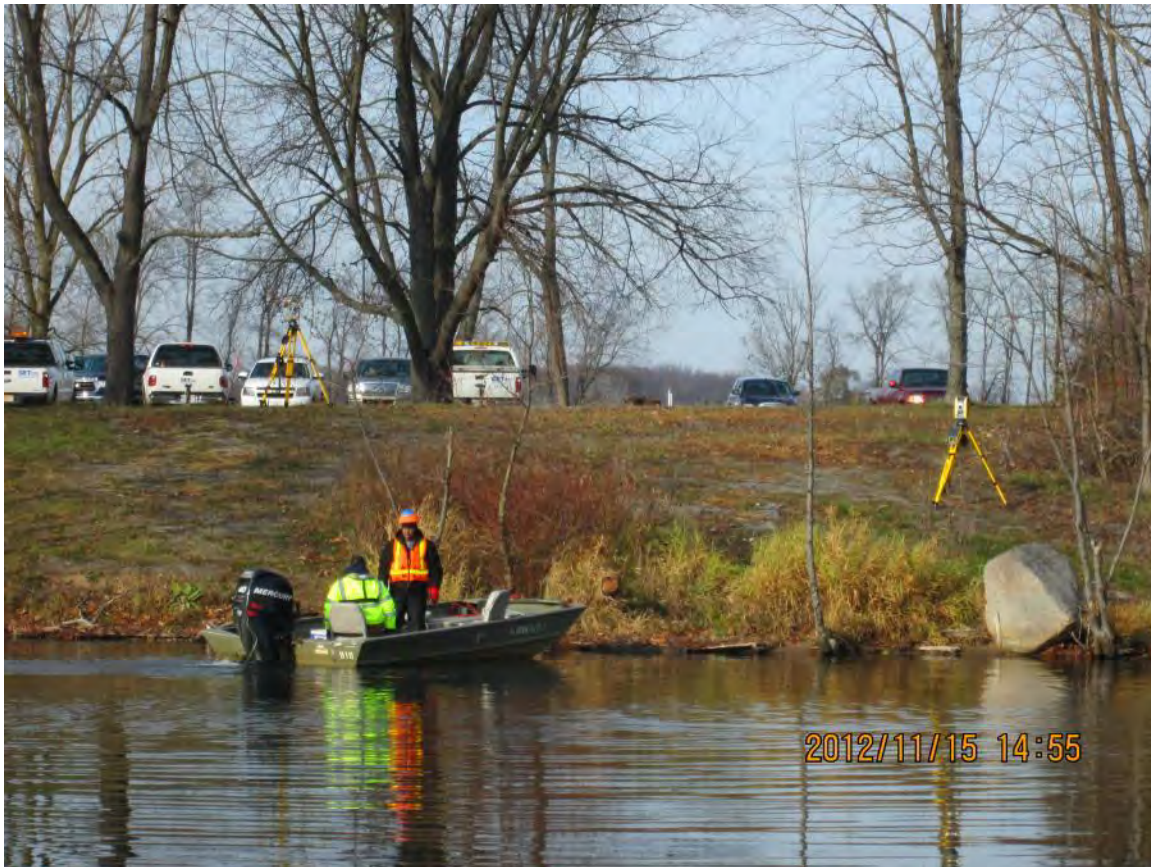
13. Morrow Lake Delta Bathymetry survey transit.

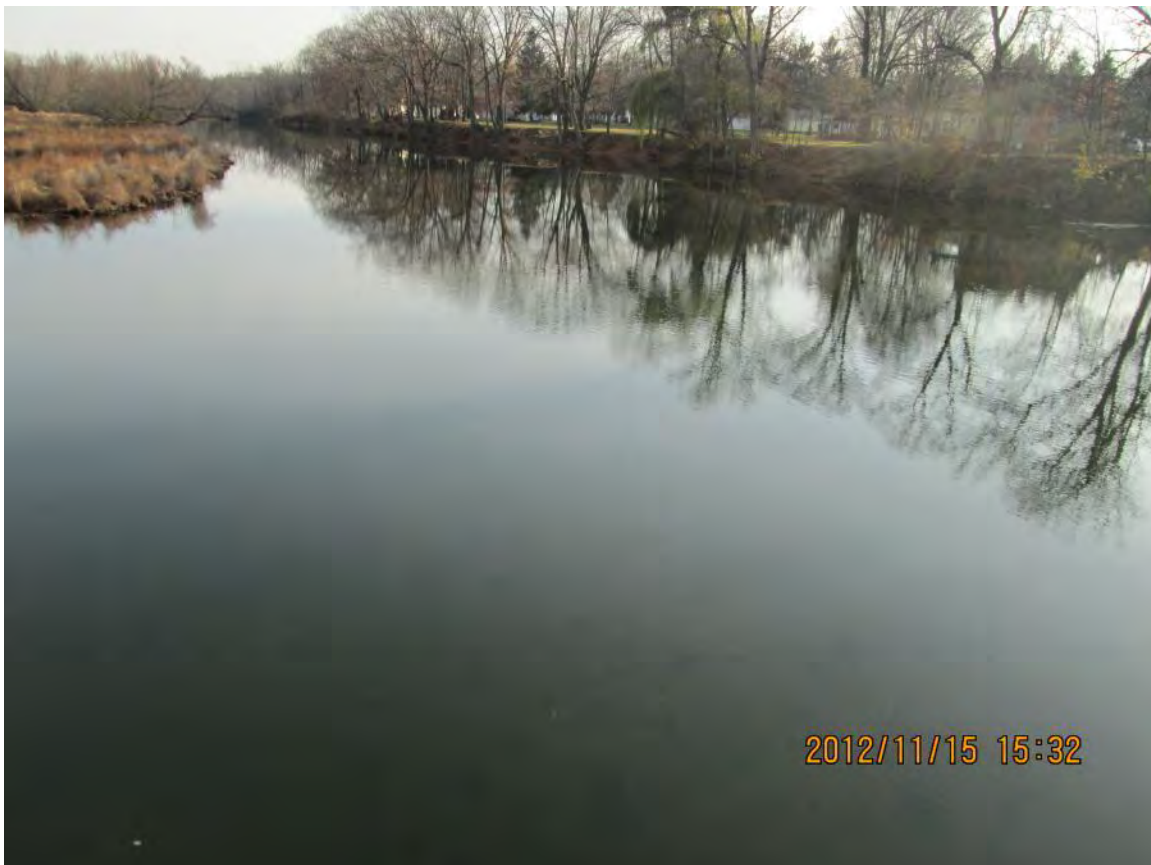
14. MP15.25 at Burnham Street Bridge area where sheen was observed.

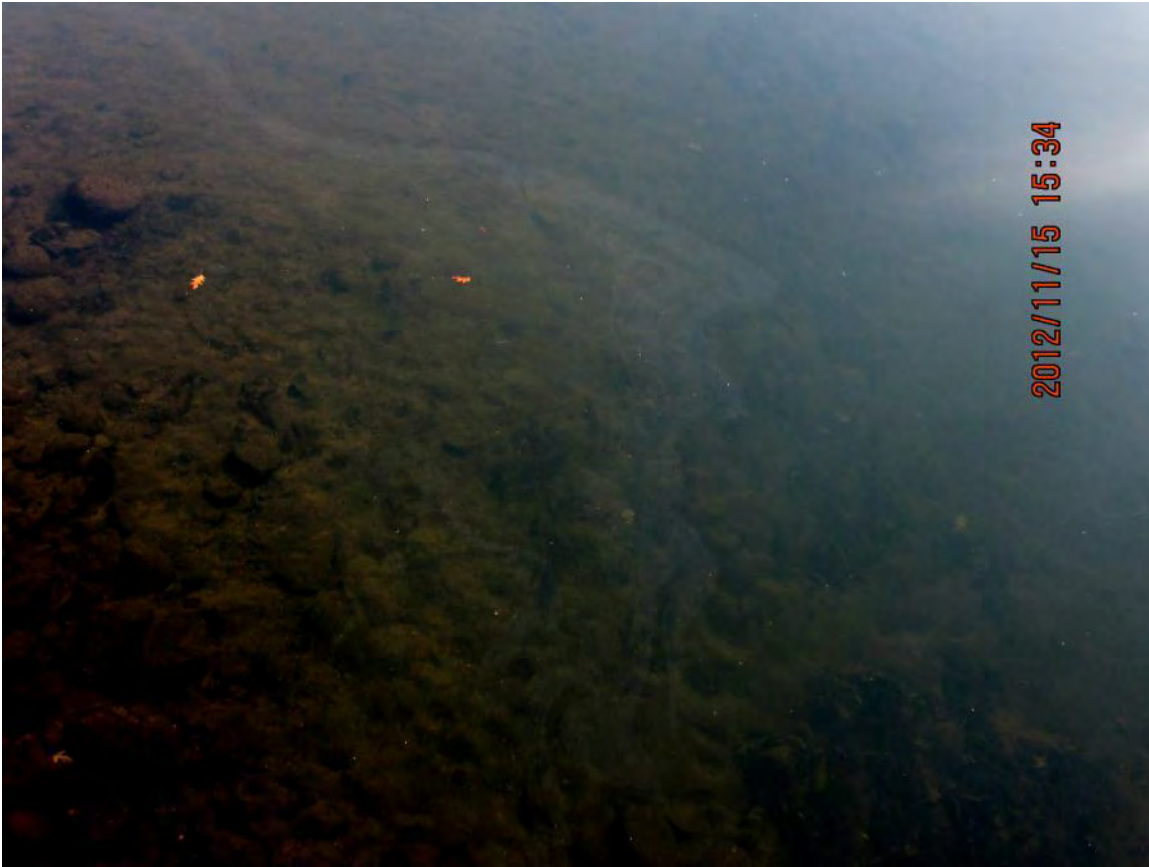
15. MP15.25 observed sheen south of Burnham Street Bridge.

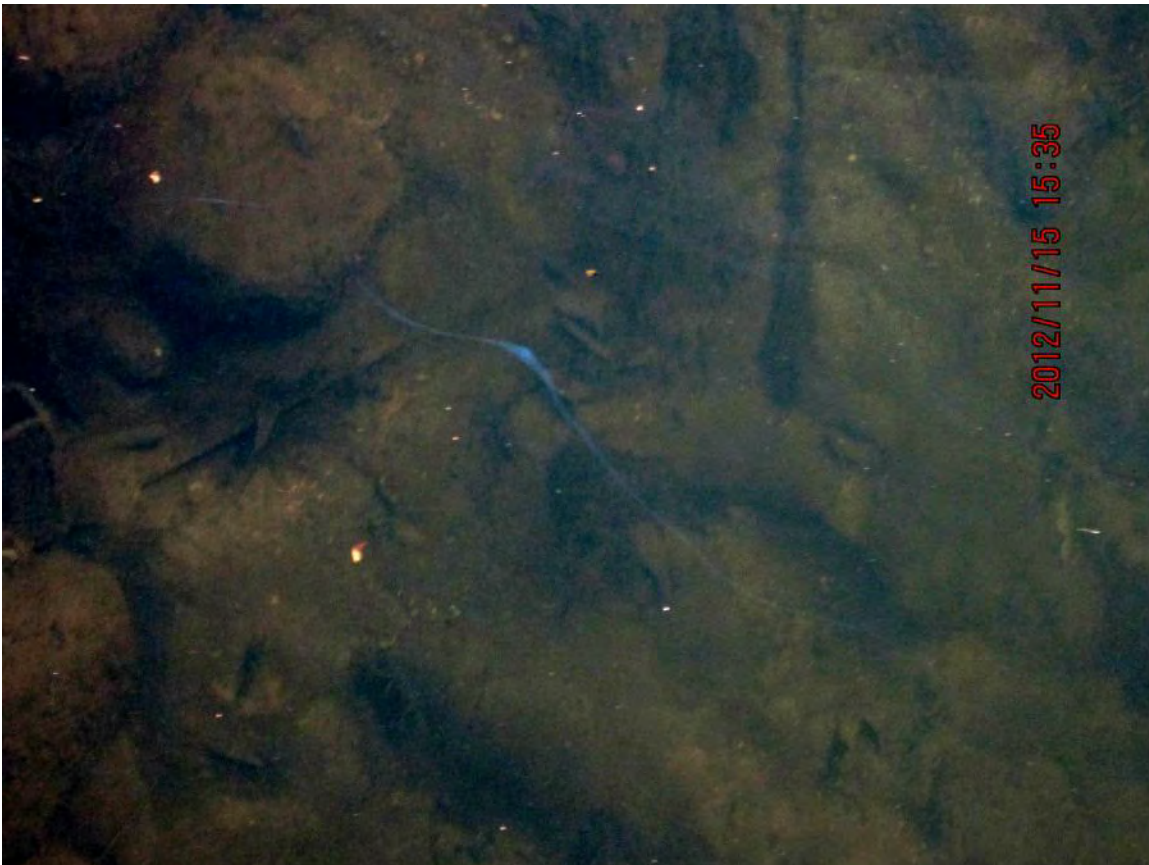
16. MP15.25 observed sheen south of Burnham Street Bridge.

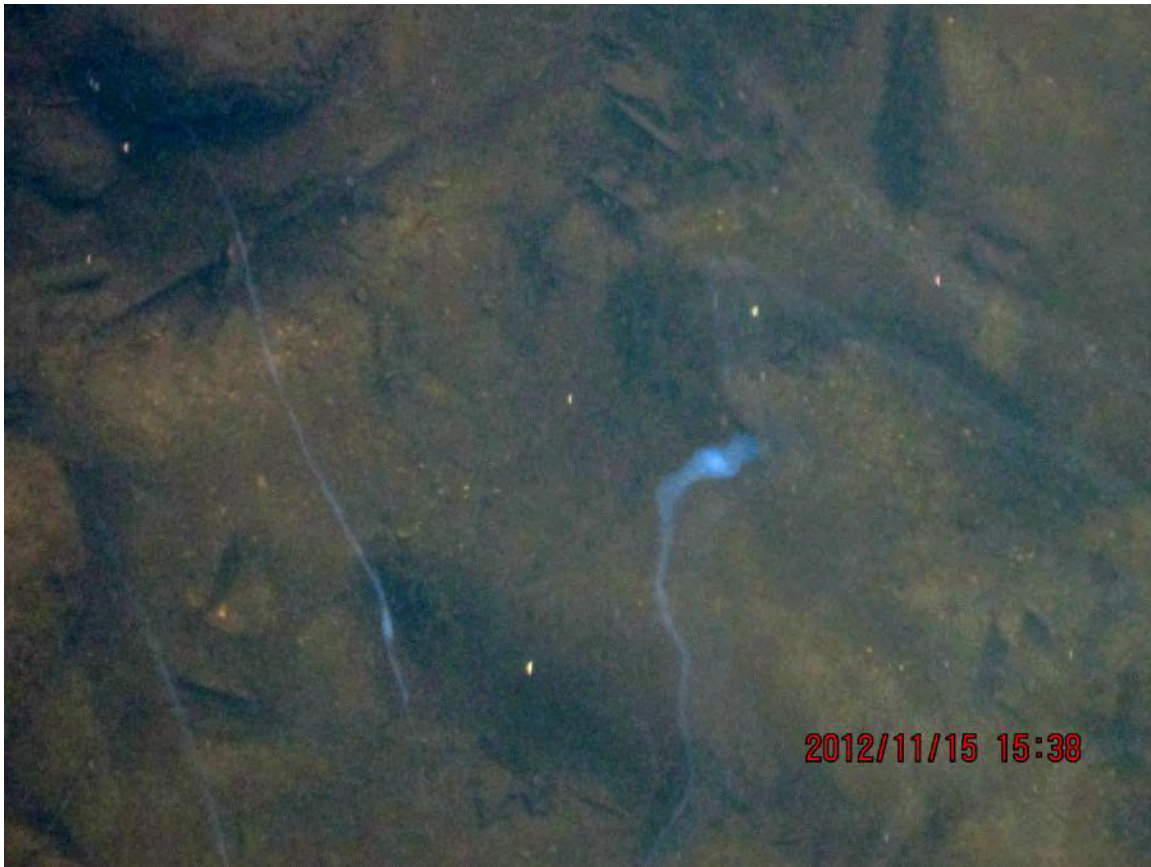
17. MP15.25 observed sheen south of Burnham Street Bridge.

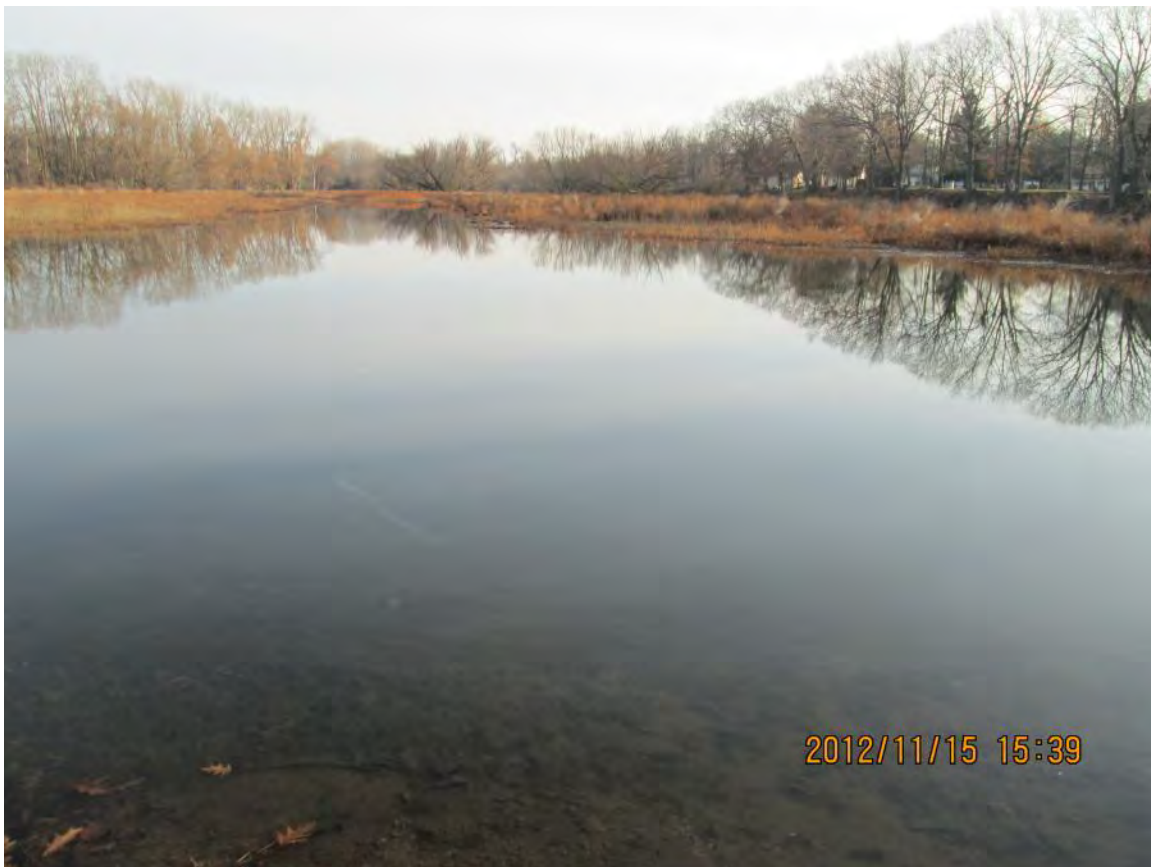
18. MP15.25 South Mill Pond where sheen was observed.

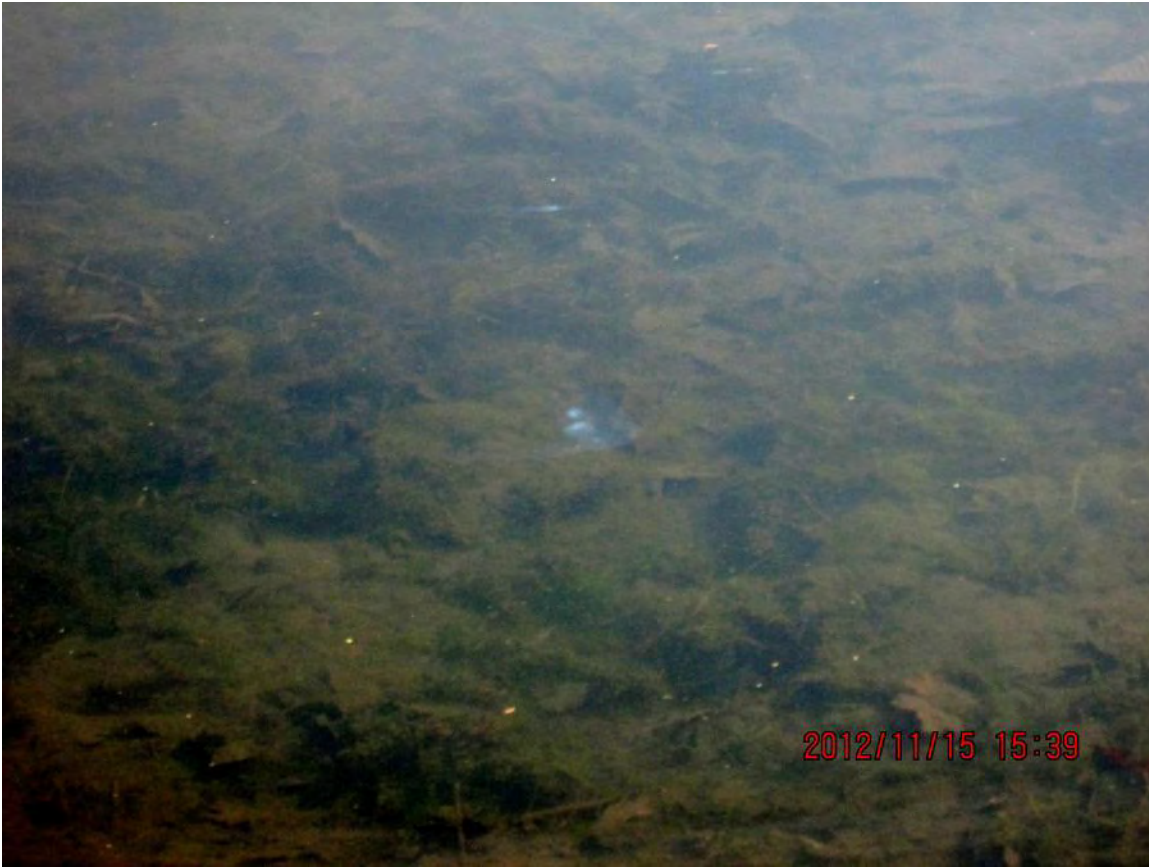
19. MP15.25 South Mill Pond observed sheen.
